Environmental Restrictive Covenant

Former Purtee Plating
2300 to 2306 East 44th Street
Indianapolis, Indiana

VAPOR INTRUSION, INSPECTION, MONITORING, AND MAINTENANCE WORK PLAN

**Former Purtee Plating
2300 to 2306 East 44th Street, Indianapolis, IN
IDEM Project Numbers 2006-05-3604 and 2006-06-154**

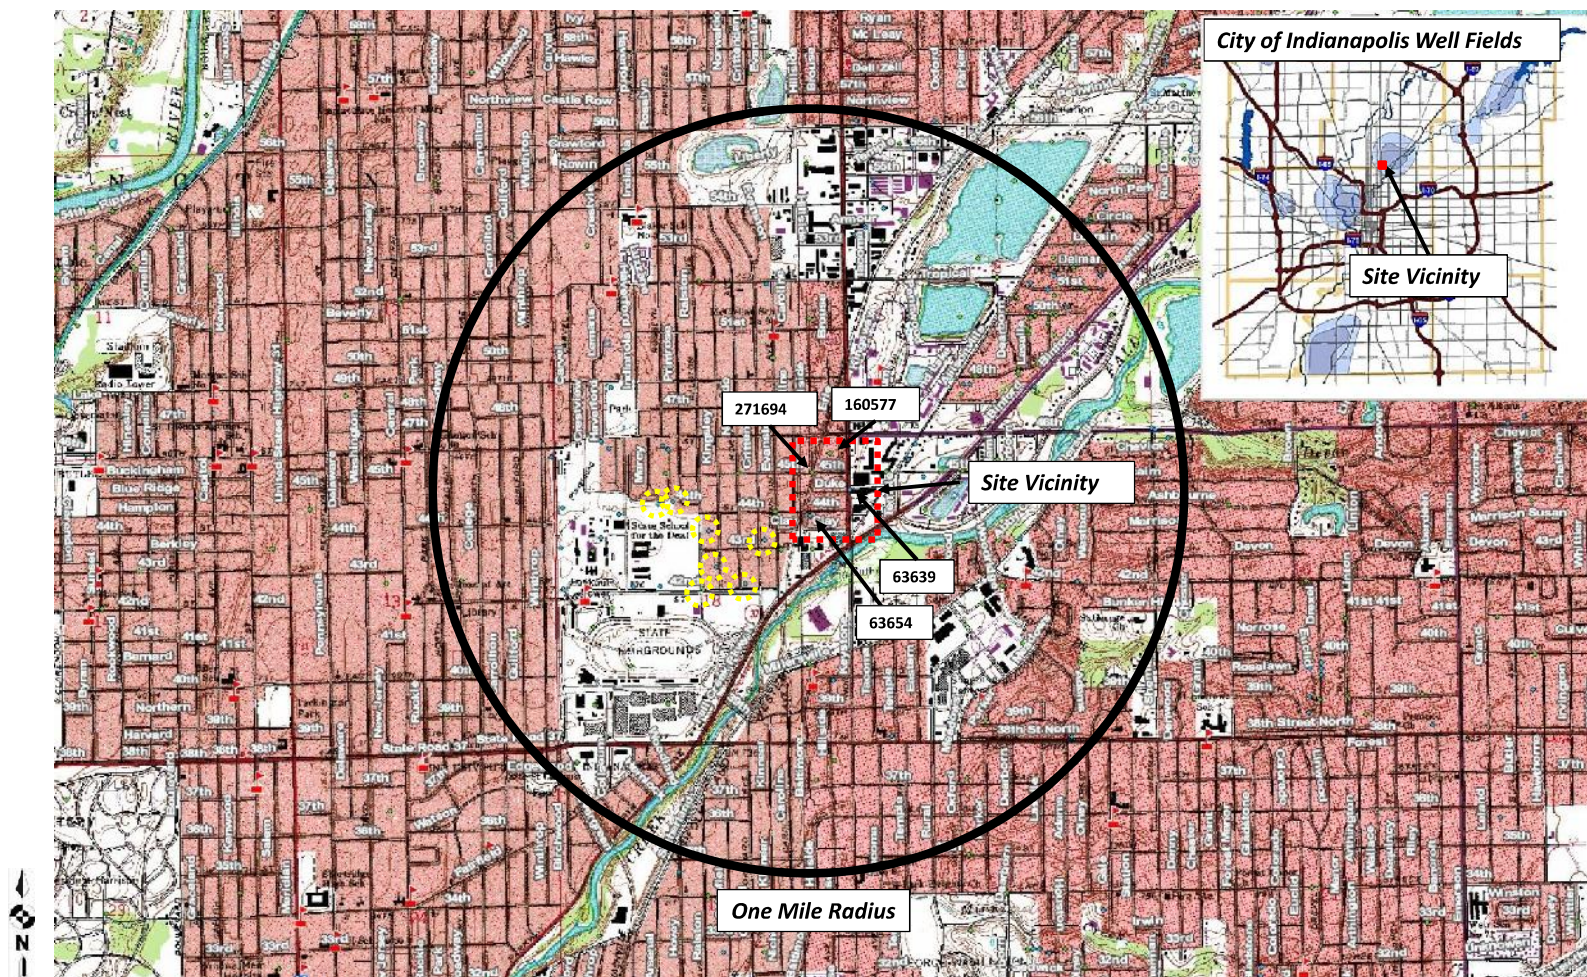
Figure 1
Site Vicinity Map

- The Site is situated in a mixed commercial, light industrial and residential setting.
- There are no known sensitive populations in the immediate vicinity of the Site.
- Ecological receptors in the vicinity of the Site include Fall Creek and associated wetlands. There are no known impacts to these receptors.

Burns Environmental Engineering, Inc. (BEE) has prepared this *Vapor Intrusion, Inspection, Monitoring, and Maintenance Plan* to outline the procedures for inspection, maintenance, and monitoring of the vapor intrusion (VI) mitigation systems installed at the Former Purtee Plating Facility at 2300 to 2306 East 44th Street, Indianapolis, Indiana (the Site). A Site Vicinity map is provided as Figure 1.

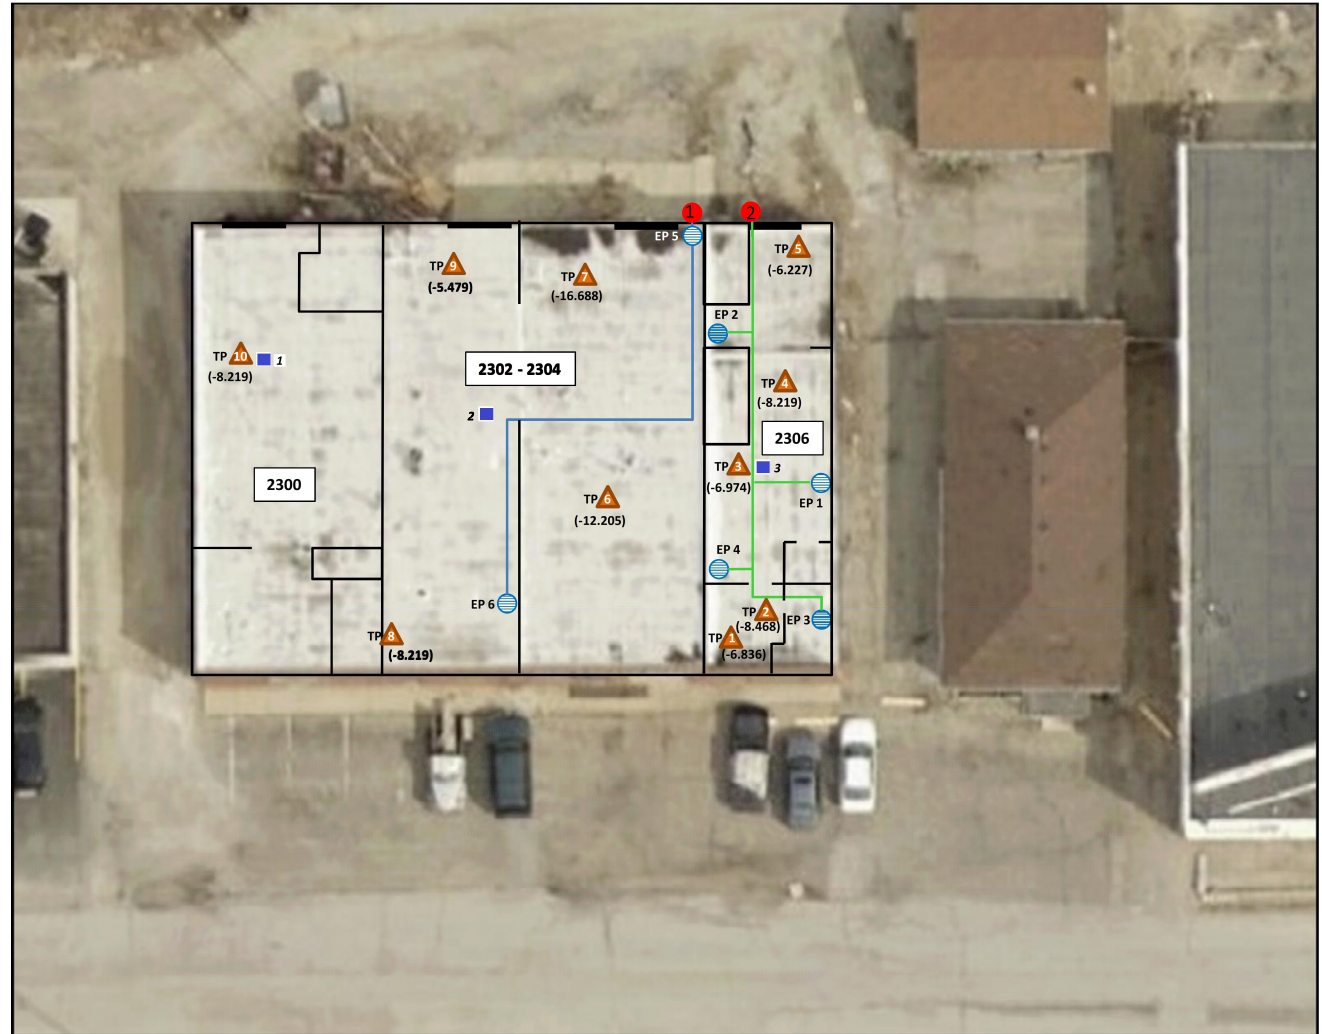
Figure 2
SSDS Layout

(-0.000) - Vacuum (Pascals) System Commissioning Results

▲ VI System Commissioning Sub-Slab Test Points

■ Permanent PFE Measurement Point

Installation of the sub-slab depressurization system was conducted by Vapor Protection Services, a certified Radon Mitigator, between June 24 and 29, 2015 under the supervision of BEE personnel. The system, which is shown in Figure 2, was designed based on diagnostic testing and professional judgement to induce a negative pressure field of at least 4 pascals throughout the area beneath the building's slab. The system consists of a total of six vapor extraction points. Each extraction point consists of a 4-inch diameter hole drilled through the building's slab, with under-slab material excavated to create a void space approximately 8-inches deep and 6-inches in diameter. Extraction points 1 through 4 are plumbed to a common header via 3-inch diameter, schedule 40 PVC pipe. Extraction points 5 and 6 are plumbed to a common header via 4-inch diameter, schedule 40 PVC pipe. Magnehelic pressure gauges are installed at the terminal end of each header in order to easily monitor the vacuum at each of the system's two vapor effluent stacks. Flow balancing between each of the system's extraction points can be performed as needed by ball valves installed in-line. Depressurization fans are installed in-line at each of the two SSDS vapor effluent stacks.

A summary of system commissioning measurements are provided as Attachment B. Sub-slab vacuum measurements obtained from each of the 10 test points were found to be in excess of 4 pascals, indicating the negative pressure field induced beneath the building meets design requirements.

Three permanent subslab monitoring ports will be installed in the building slab at the approximate locations shown in Figure 2. The subslab monitoring ports will flush-mounted to the building slab and have tamper-resistant caps. The subslab monitoring ports will be used for PFE monitoring to determine whether a negative subslab pressure exists. A negative pressure of 4 pascals or more at each of the subslab

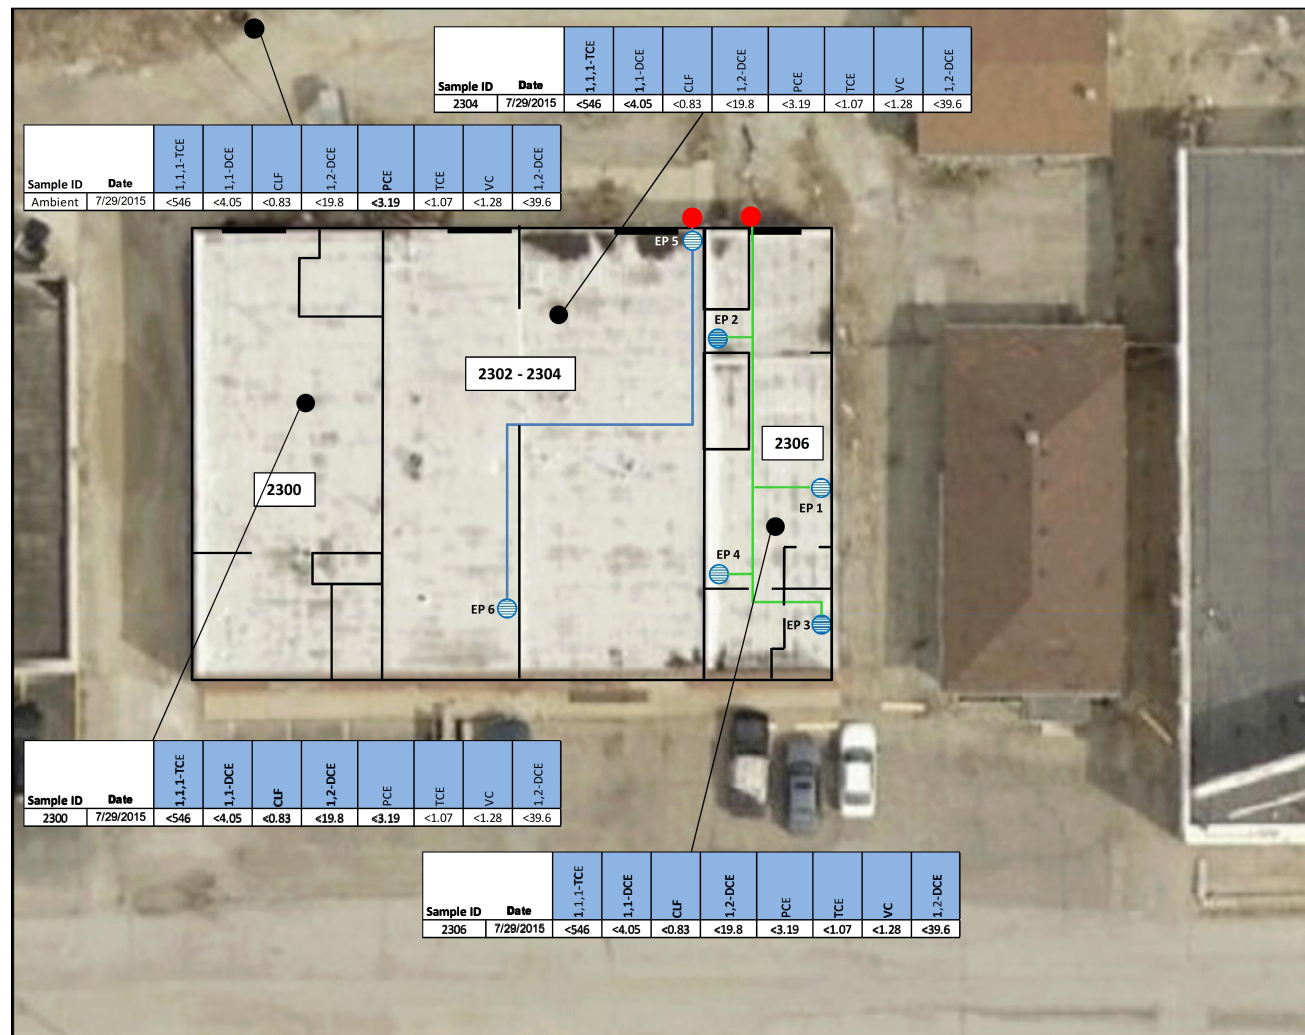
Figure 3
SSD Verification Sampling
Location and Results

Screening Levels - Indoor Air		
	Residential	Industrial / Commercial
1,1,1-TCE Trichloroethane, 1,1,1-	5200	22000
1,1-DCE Dichloroethane, 1,1-	15	77
CLF Chloroform	1.1	5.3
1,2-DCE Dichloroethylene, 1,2-cis-		
PCE Tetrachloroethylene	21	180
TCE Trichloroethylene	2.1	8.8
VC Vinyl Chloride	1.6	28
1,2-DCE Dichloroethylene, 1,2-trans-	63	260

All data in $\mu\text{g m}^{-3}$

Verification indoor air samples were collected between June 28 and June 29 at locations identified in Figure 3 by placing a 6-L Summa canister approximately 3 feet above the floor. The 3 to 5 foot interval was used to be representative of the breathing zone. The samples were collected with 24-hour flow regulators attached to each Summa canister. All connections between the Summa canisters and flow regulators were secured with laboratory-provided threaded connections sealed with Teflon tape. All samples were submitted to EnvisionAir under chain of custody protocols for analysis of VOCs historically identified as contaminants of potential concern (COPCs), or identified in sub-slab samples during BEE's previous vapor intrusion screening investigation, using USEPA Test Method TO-15.

Laboratory analytical results obtained during the indoor air verification testing performed on June 28 and June 29, 2015 are summarized in Figure 3. All constituents identified in sub-slab soil gas during BEE's VI screening level investigation were found to be below both laboratory detection limits and residential vapor intrusion screening levels.

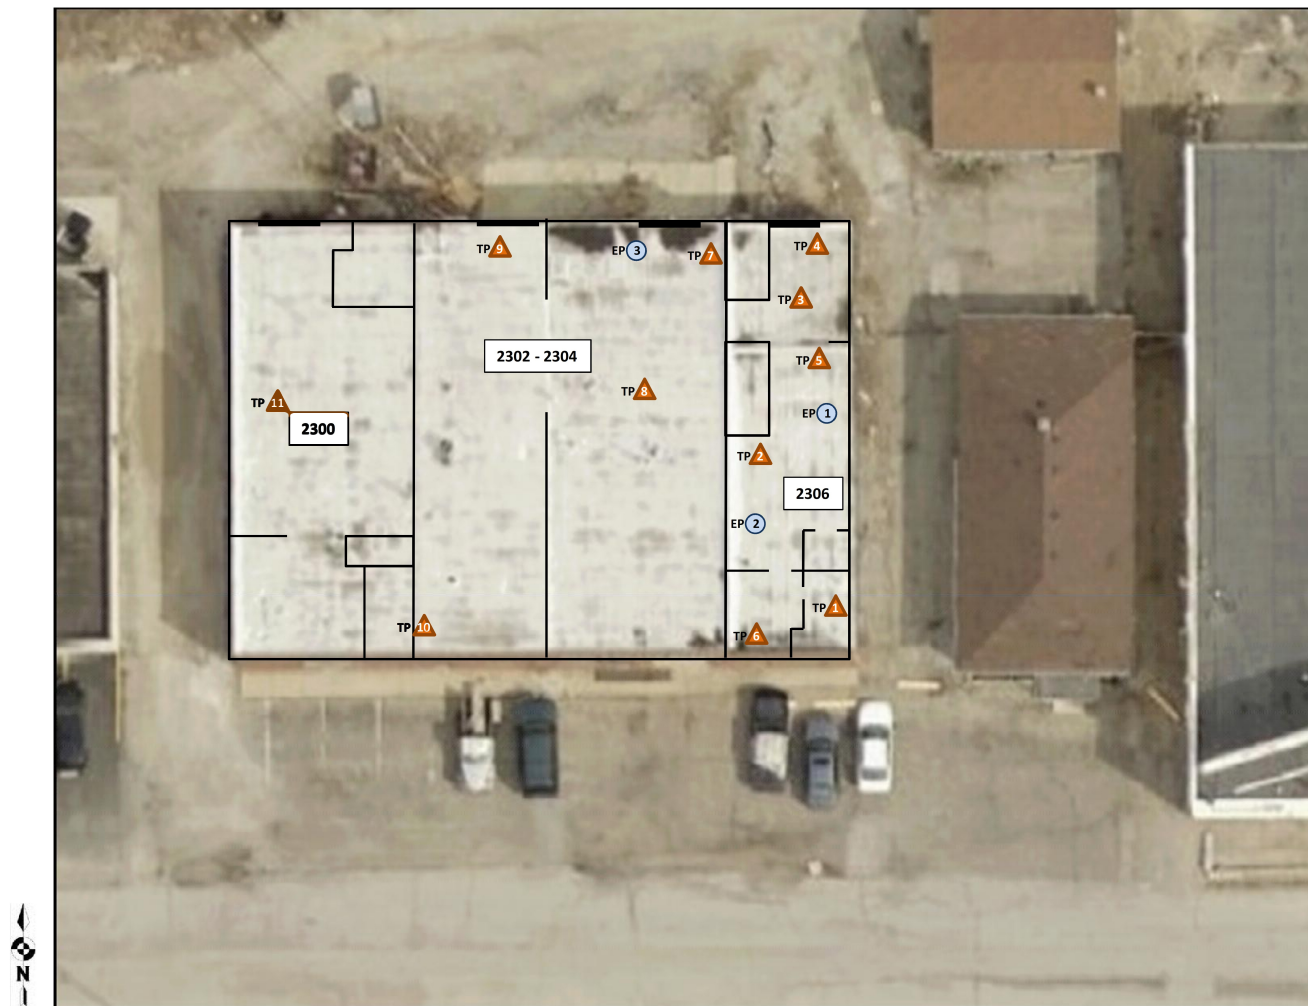
Attachment A
Vapor Intrusion Mitigation
Diagnostic Test Results

- VI Mitigation Diagnostic Testing Points
-

- VI Mitigation Diagnostic Extraction Points
- 2300

Design testing for the SSDS was conducted by Vapor Protection Services on March 16, 2015 under the supervision of BEE personnel. The testing included the installation of three temporary extraction points and 11 pressure field test points installed throughout the footprint of the building's slab. Each extraction point consisted of a 4-inch diameter holes drilled through the building's slab, with under-slab material excavated to create a void space approximately 8-inches deep and 6-inches in diameter. Pressure field test points consisted of 0.5-inch diameter holes drilled through the slab and approximately 3-inches into the underlying sub-slab material. A vacuum was then created at each extraction point using a portable two-stage vacuum blower in order to produce extraction air flows ranging between 50 and 68 cubic feet per minute (CFM). Vacuum measurements were then obtained from surrounding test points in order to determine the resulting negative pressure field beneath the building slab. A summary of test data is provided as Attachment A.
